**PAINT COLOR INVESTIGATION  
AND  
CHINKING/DAUBING ANALYSIS**

Smith-Taylor Cabin  
Shelter Island, New York

*Prepared by:*  
Jablonski Building Conservation, Inc.  
40 West 27<sup>th</sup> Street, Suite 1201  
New York, NY 10001

February 10, 2012

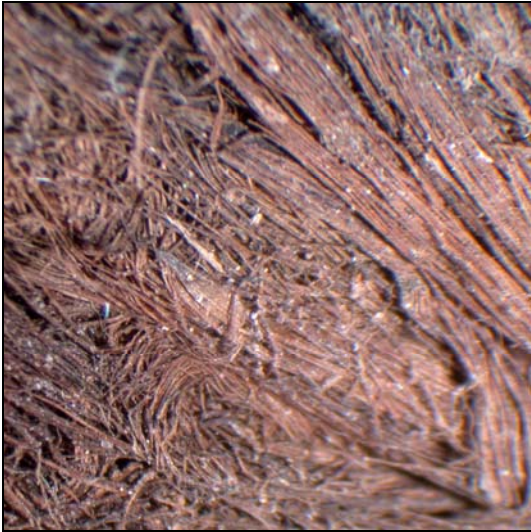
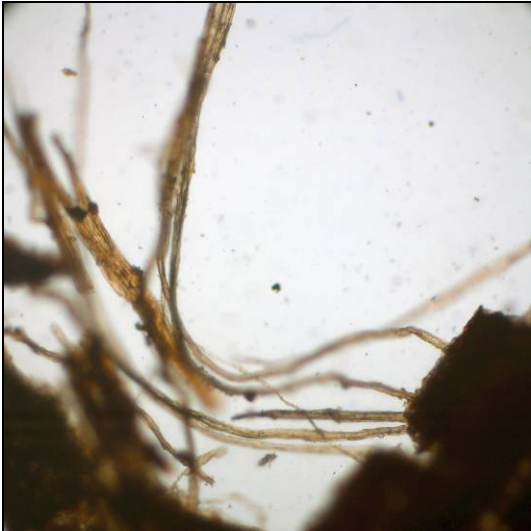
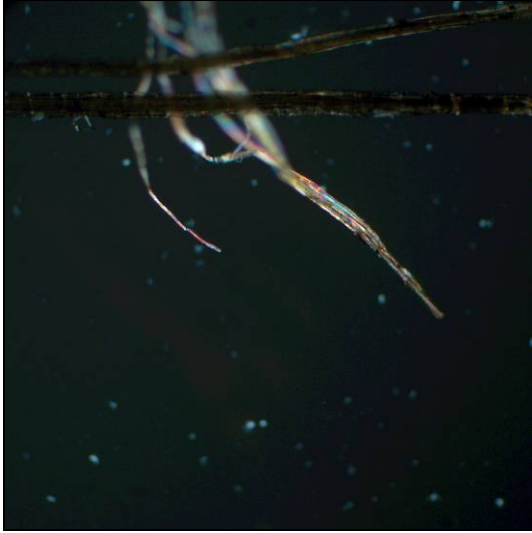
These are transparent, colorless to pale yellow, generally straight, smooth cylinders with occasional cross markings (nodes).... Both ends of the fiber taper to points.... These bast fibers are most likely to be seen in bundles, since jute is usually used in bast form and seldom separated down to the individual fibers.<sup>7</sup>

| Microscopic Examination of Chinking Fibers | |
|---|---|
| <p><b>Figure 3:</b> Dark grayish brown fiber under normal reflected light (daylight simulation).</p> | <p><b>Figure 4:</b> Greenish gray fiber under normal reflected light (daylight simulation).</p> |
| <p><b>Figure 5:</b> Dark grayish brown fiber under polarized light at 10X magnification.</p> | <p><b>Figure 6:</b> Greenish gray fiber under polarized light at 10X magnification.</p> |

**Figure 7:** Dark grayish brown fiber under cross-polarized light at 10X magnification.

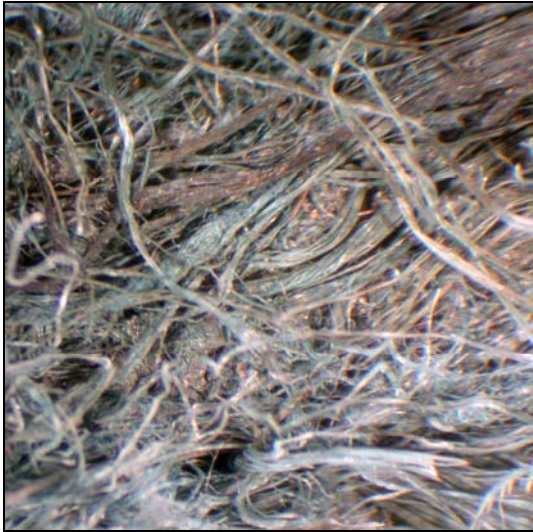
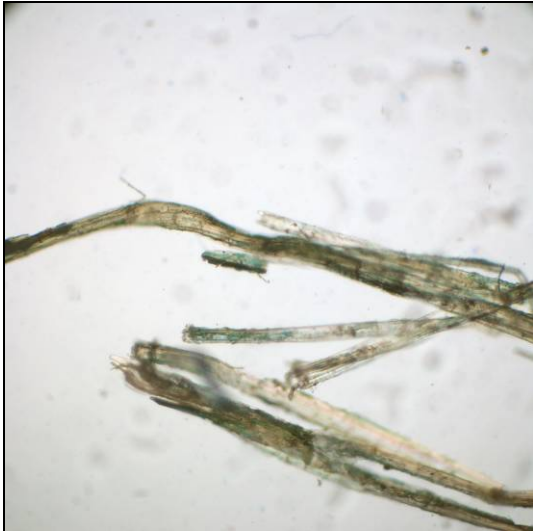
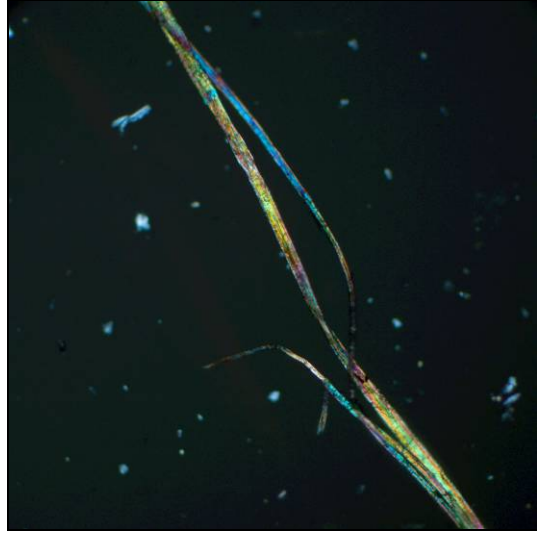
The greenish gray color of one of the fiber clusters is indicative of oakum. Oakum is loosely twisted jute fiber that has been impregnated with tar or a tar derivative. It was commonly packed into joints and was used because it is repellent to insects and rodents and is resistant to decay.

**Figure 8:** Greenish gray fiber under cross-polarized light at 10X magnification.

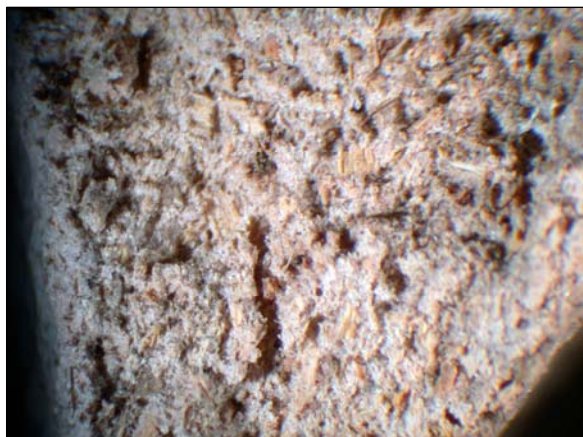
Based on the provided sample, the daubing appears to be approximately 5/8" wide. In cross-section the matrix of the daubing appears to be very pale brown (Munsell 10YR 7/3) in color with many wood pulp fibers visible. The daubing was fairly compact but had many voids in cross section. The daubing sample was moderately soft and relatively easy to crush with a mortar and pestle. On a scale of 1 to 5 with 1 being soft and 5 being hard, the daubing was a 3 in hardness.

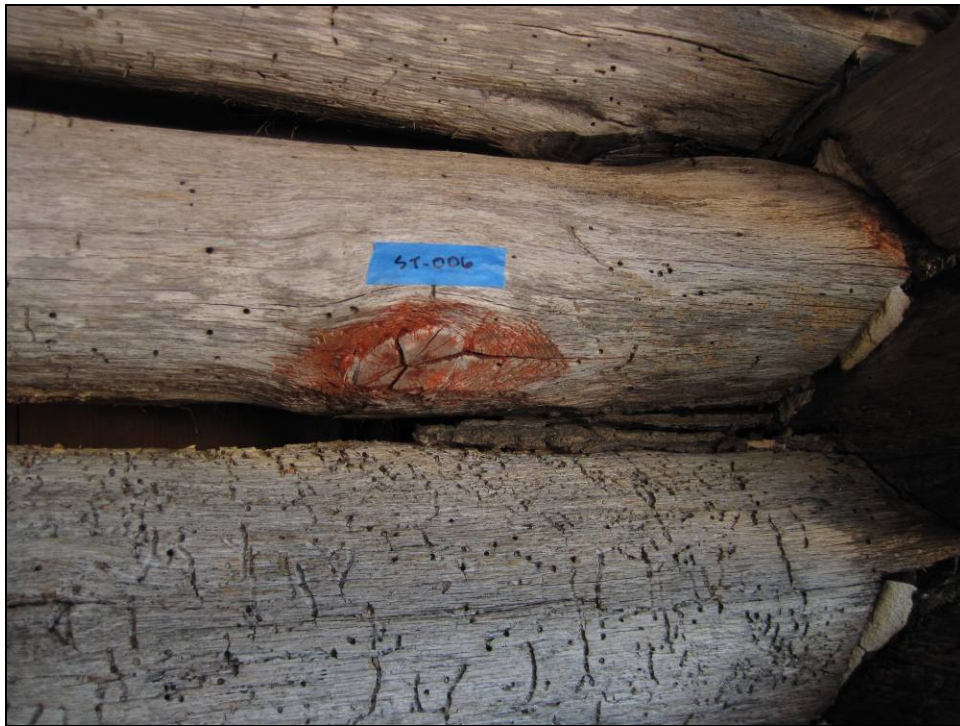
**Figure 9:** The chinking / daubing between the logs is mostly missing; where present, the chinking / daubing is severely deteriorated.

The chinking and daubing used on the Smith-Taylor Cabin should be replaced where necessary, but only once all log replacements or repairs have been completed. Loose daubing that is not securely attached to the logs should be carefully removed so that the joints can be better sealed. Based on the heavy deterioration of the existing logs and chinking/daubing, all remaining chinking/daubing should be removed and replaced.

Commercially available chinking products should not be used on this historic log structure. A chinking / daubing mixture that matches the original, based on the above analysis, should be used. The basic techniques for the repair of the chinking and daubing should adhere to the National Park Service's *Preservation Brief 26: The Preservation and Repair of Historic Log Structures*:

We recommend keeping the cement to a minimum in a daub mix. Cement can do irreparable damage to log structures because of its minimally porous qualities and rigidity. Its density reduces uniform breathability causing logs to become saturated with water and quickly leading to rot.

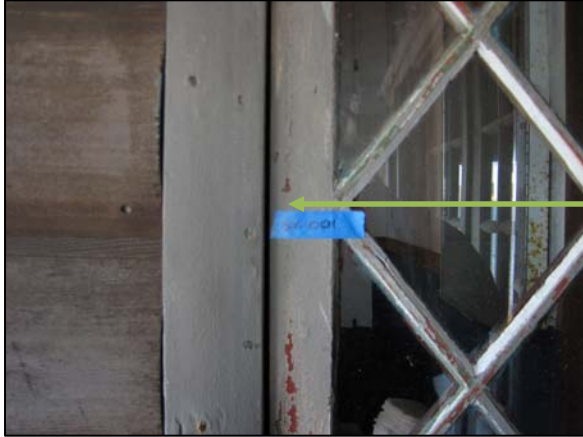
**Sample ST-001**

Samples ST-001 and ST-002 were taken from the north facing wall of the east side of an addition. The sash, sample ST-001 is very weathered and has fewer layers than the frame. The frame appears to have been stained with a dark brown and varnished with a clear but yellowed coat. A later dark brown varnish was applied and later still the frame was painted green. The sash of the same window appears to have been painted green from its beginning with at least one coat of brownish red followed by green again. This analysis could not determine if the frame and sash date to the same period as the wood and paint are extremely deteriorated.

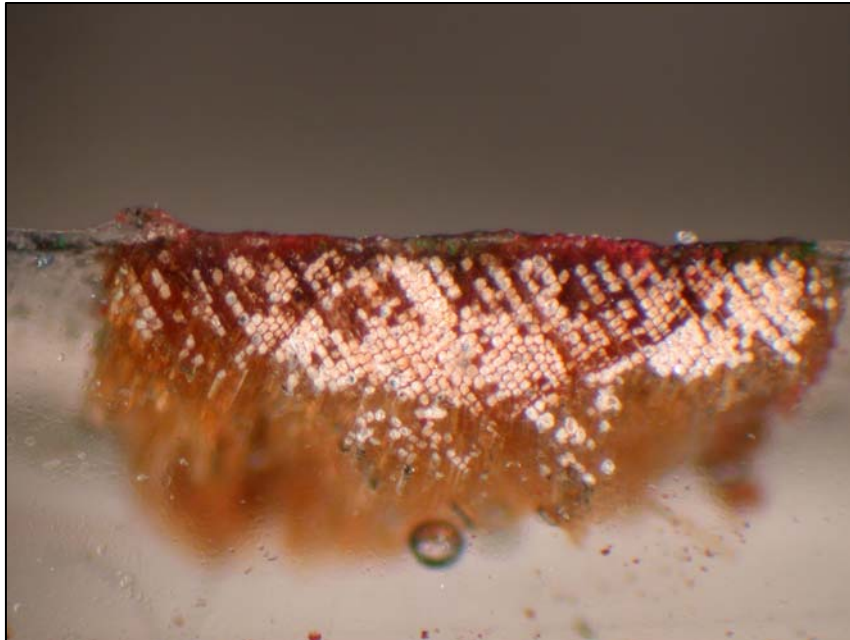
Sample ST-001

- 1<sup>st</sup> Color layer matches layer #4 on Sample ST-002
- 1<sup>st</sup> layer is very weathered.

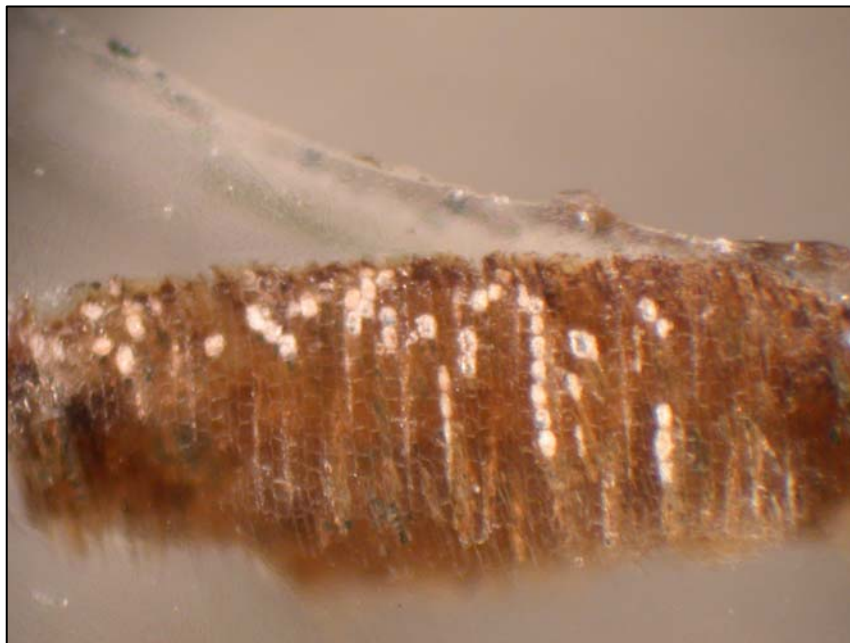
Sample ST-004

- The dark brown varnish is very aged.

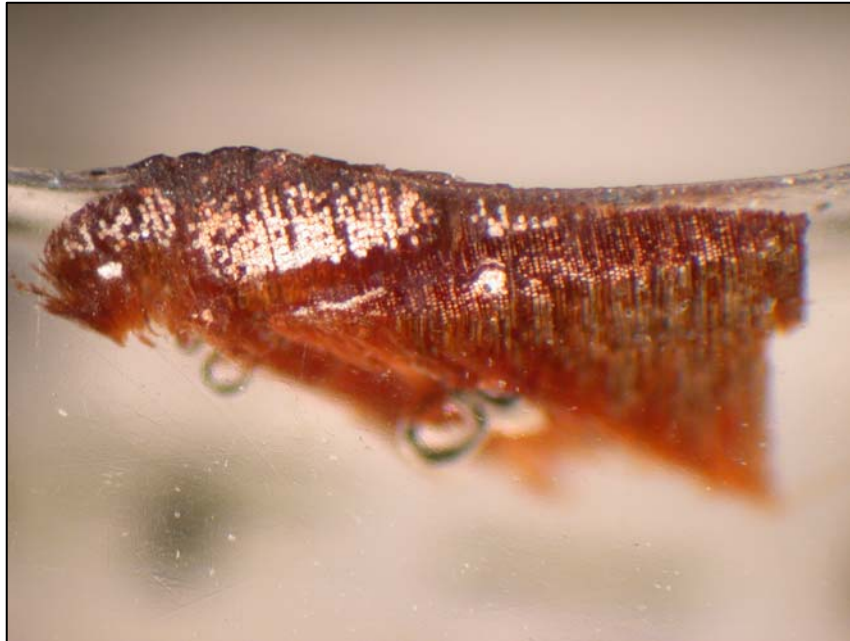
Sample ST-007

- UV degraded wood

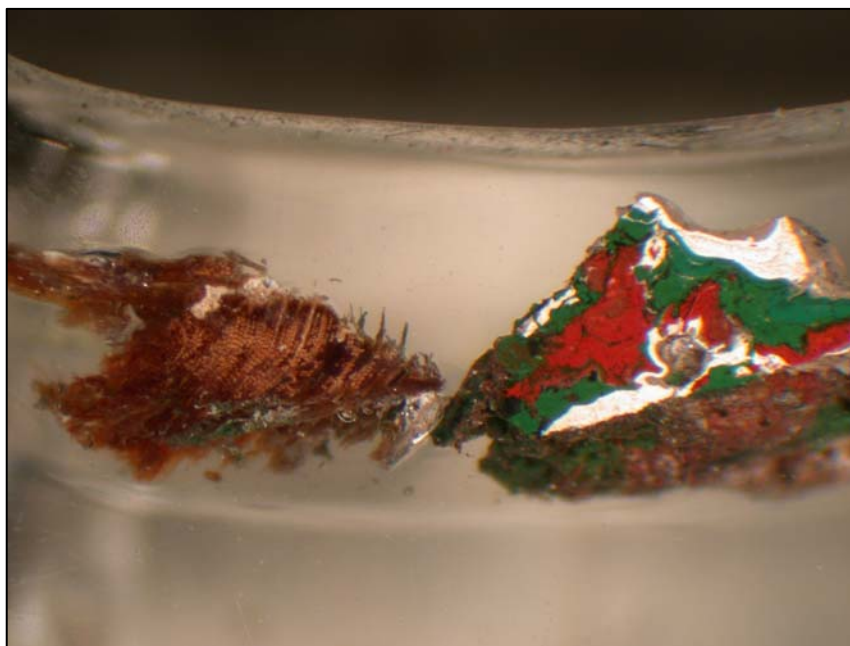
Sample ST-014

- Very weathered wood

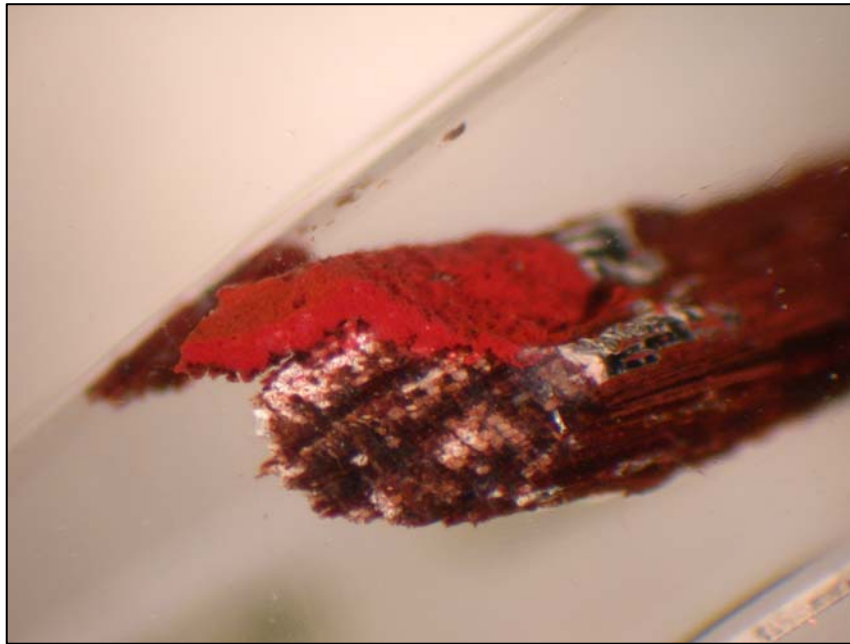
Sample ST-016

The tower has extremely weathered wood on all surfaces. One paint sample (ST-016) was taken from the south side approximately 3 foot from the walkway where the paint appeared to have several layers. In the sample, the wood is dark brown not the light brown one expects to see if the wood had been coated regularly. Only three layers were found and they look to have been relatively recent painting campaigns. The first layer was a white primer and the two additional layers were red brown layers with the first reddish brown slightly redder than the second.
