**PAINT COLOR INVESTIGATION  
AND  
CHINKING/DAUBING ANALYSIS**

Smith-Taylor Cabin  
Shelter Island, New York

*Prepared by:*  
Jablonski Building Conservation, Inc.  
40 West 27<sup>th</sup> Street, Suite 1201  
New York, NY 10001

February 10, 2012

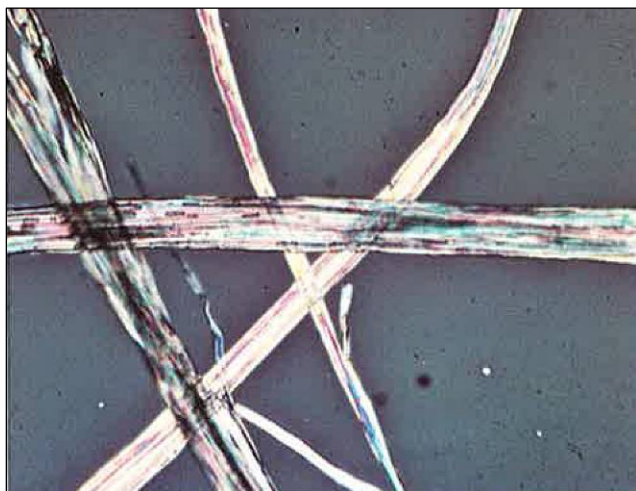
There were two different colored fibers in the chinking sample. One cluster of fibers was dark grayish brown (Munsell 10YR 3.5/2) and one was greenish gray (10GY 4/1 – 10BG 5/1). During microscopic examination it was verified that the greenish gray sample had what appeared to be blue dye on the fiber. Both the dark grayish brown and greenish gray plant fibers in the chinking were analyzed separately but were each identified as jute. A description of the appearance of jute in polarized light during microscopic examination is as follows:

These are transparent, colorless to pale yellow, generally straight, smooth cylinders with occasional cross markings (nodes).... Both ends of the fiber taper to points.... These bast fibers are most likely to be seen in bundles, since jute is usually used in bast form and seldom separated down to the individual fibers.<sup>7</sup>

The greenish gray color of one of the fiber clusters is indicative of oakum. Oakum is loosely twisted jute fiber that has been impregnated with tar or a tar derivative. It was commonly packed into joints and was used because it is repellent to insects and rodents and is resistant to decay.

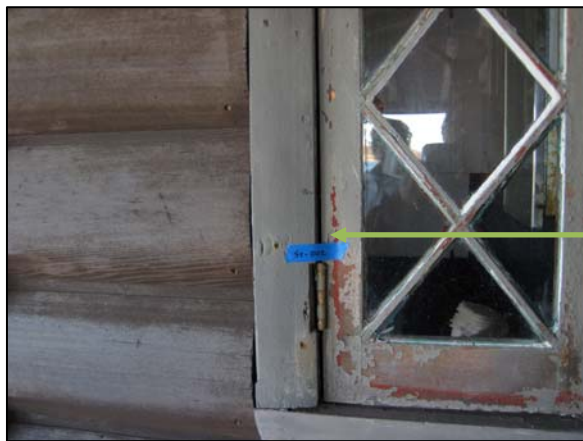
**Sample ST-002**

Samples ST-001 and ST-002 were taken from the north facing wall of the east side of an addition. The sash, sample ST-001 is very weathered and has fewer layers than the frame. The frame appears to have been stained with a dark brown and varnished with a clear but yellowed coat. A later dark brown varnish was applied and later still the frame was painted green. The sash of the same window appears to have been painted green from its beginning with at least one coat of brownish red followed by green again. This analysis could not determine if the frame and sash date to the same period as the wood and paint are extremely deteriorated.

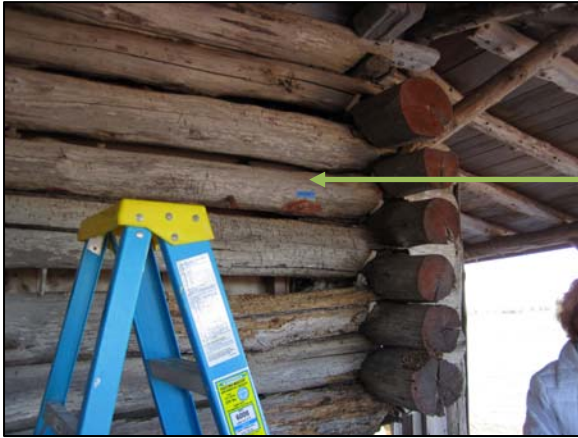
**Sample ST-006**

The logs were originally bark covered and some of this evidence remains. However, once the bark was lost, the surfaces began to be painted (ST-006 and ST-011). There is more paint on the logs adjacent to the west entrance (ST-011) than the log sampled on the east wall (ST-006). The first coating found on west entrance was a dark brown stain. The dark reddish brown is a much more recent application. A vertical log or portion of a log sampled on the east elevation next to the French doors has a finish very similar to the French doors of a stain that appears to have a later clear, slightly yellowish varnish.

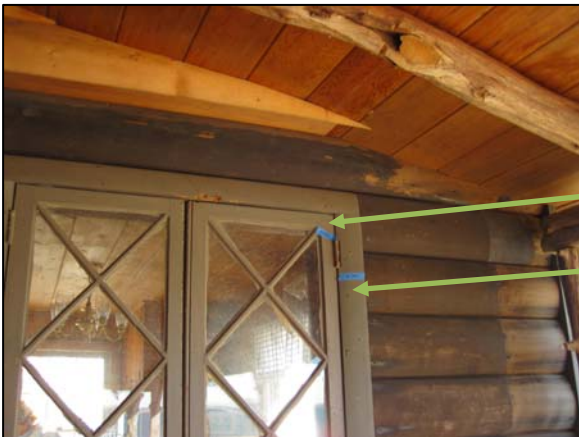
**Sample ST-012**

On the west elevation addition, the window sampled (ST-012 and ST-013) had a dark brown stained window frame that was varnished. The sash was painted initially a dark reddish brown and then a dark green.

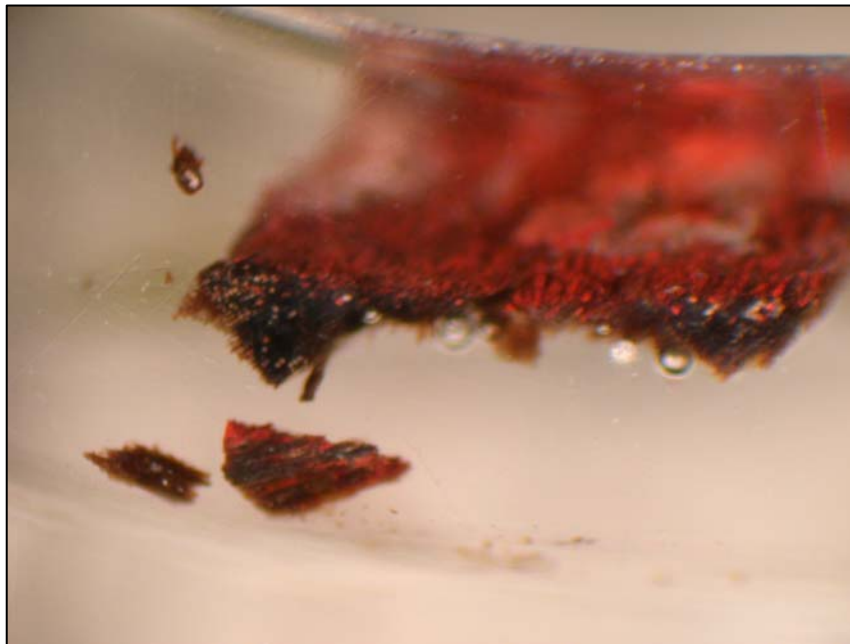
Sample ST-008

The door that is currently painted red and green on the north elevation appears to have been painted from the beginning. The diamond light insert (ST-008) has two red layers and both layers were very similar in color. The outer door rail (ST-009) has two layers of dark green that have faded. The painted door frame around this door (ST-010) is quite interesting and has multiple layers of paint. It was originally stained dark brown and varnished. It was then painted blue for two painting campaigns and then twice painted dark green.
